Preliminary Information

PIP3423N DTC P0016 P0017 P0018 P0019 P0008 P0009

Vehicles equipped with 2.8 LP1, 2.8 LAU, 3.0 LF1, 3.0 LFW, 3.6 LFX, 3.6 LLT, or 3.6 LY7 HFV6 engines may exhibit two or more of the following DTCs: P0016, P0017, P0018, P0019, P0008 or P0009.

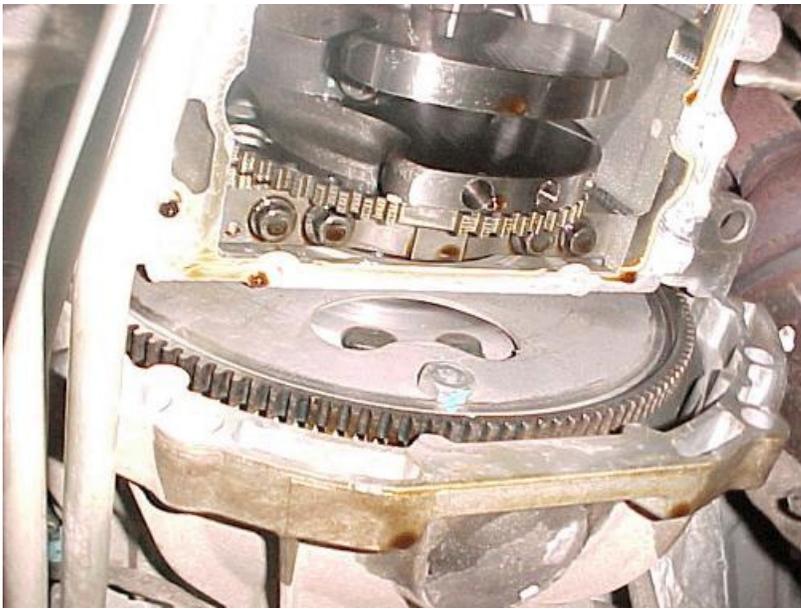
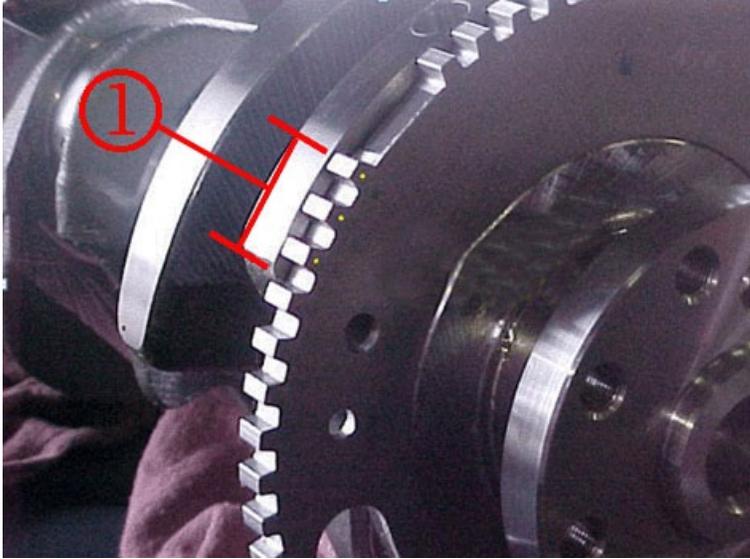
1= The actual measurement of a good Reluctor wheel.

25 to 26 mm This measurement is from the end of the machined surface of the crankshaft throw to the edge of the open space in the reluctor. (approximately 3 1/2 teeth)

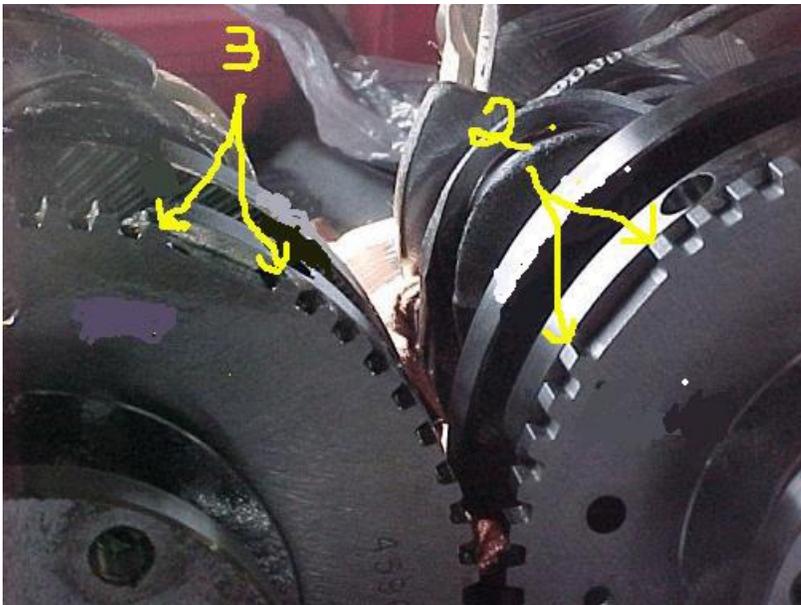
2 and 3 = Show a good reluctor next to a bad reluctor.

If the reluctor has moved then replace crankshaft.

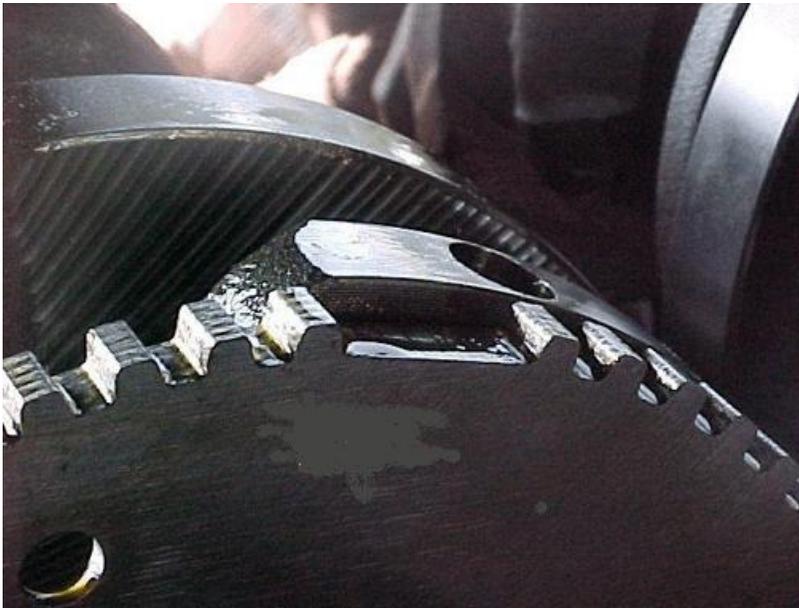
Crankshaft with bad reluctor wheel.

NOTE: The distance can be offset either clockwise or counter clockwise. Both will result in these codes.

NOTE: The balance hole does not come into play when determining if the reluctor has slipped or not.
